Map 5.5-1
Portland Harbor RI/FS
Remedial Investigation Report
Transition Zone Water Chemistry
Total DDX ($\mu\text{g/L}$)
River Mile 6.8 to 7.8

Portland Harbor RI/FS
Remedial Investigation Report
Transition Zone Water Chemistry
Total PAHs ($\mu\text{g/L}$)
River Mile 04 to 05

**Portland Harbor RI/FS
Remedial Investigation Report
Transition Zone Water Chemistry
Total PAHs (μ g/L)
River Mile 05 to 06**

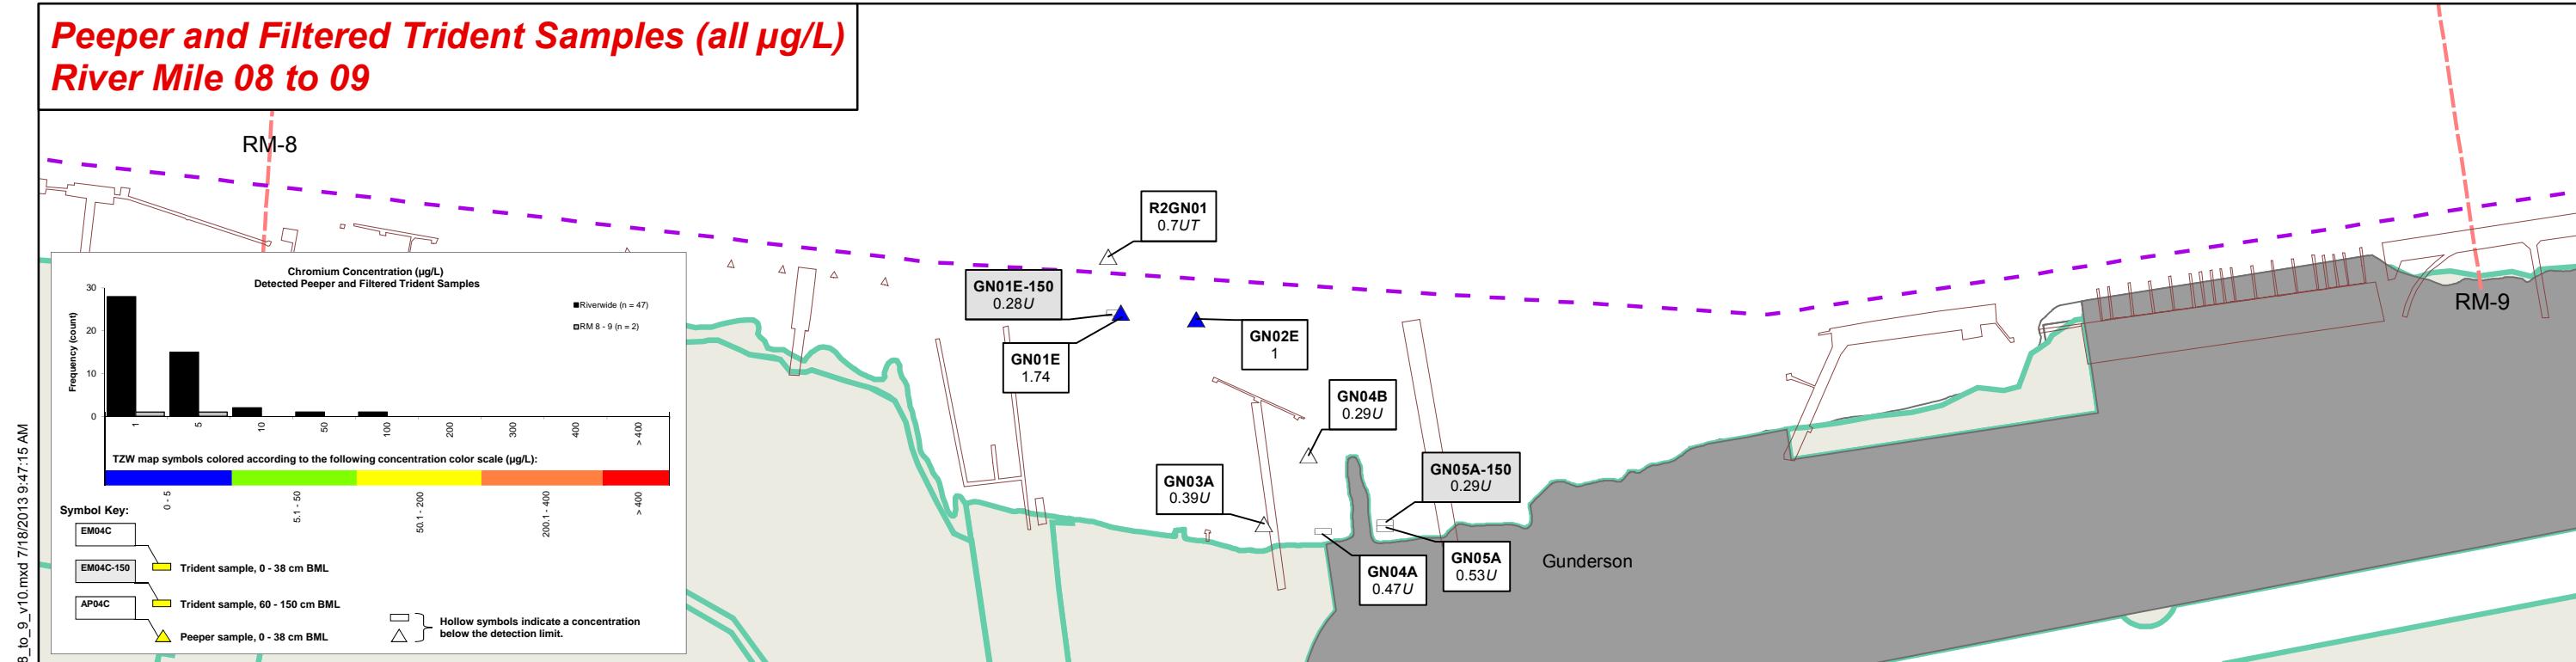
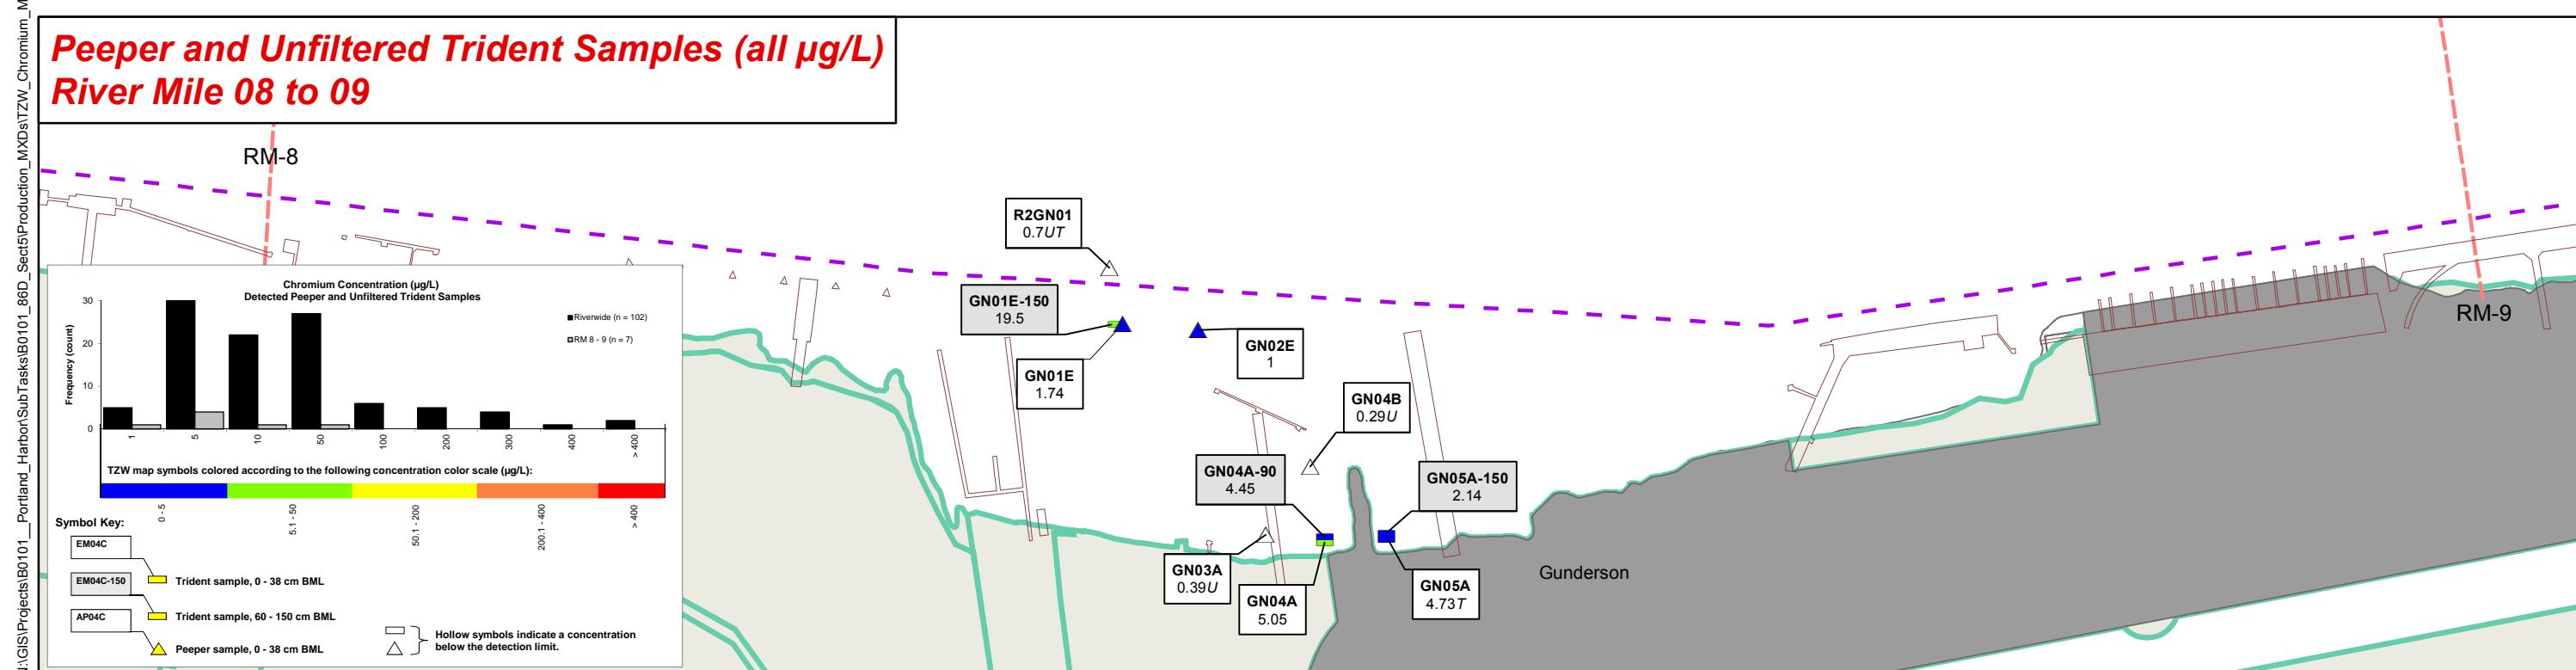
Map 5.5-4e
Portland Harbor RI/FS
Remedial Investigation Report
Transition Zone Water Chemistry
Chromium (µg/L)
River Mile 08 to 09

Pepper and Filtered Trident Samples (all µg/L)
River Mile 08 to 09

Pepper and Unfiltered Trident Samples (all µg/L)
River Mile 08 to 09

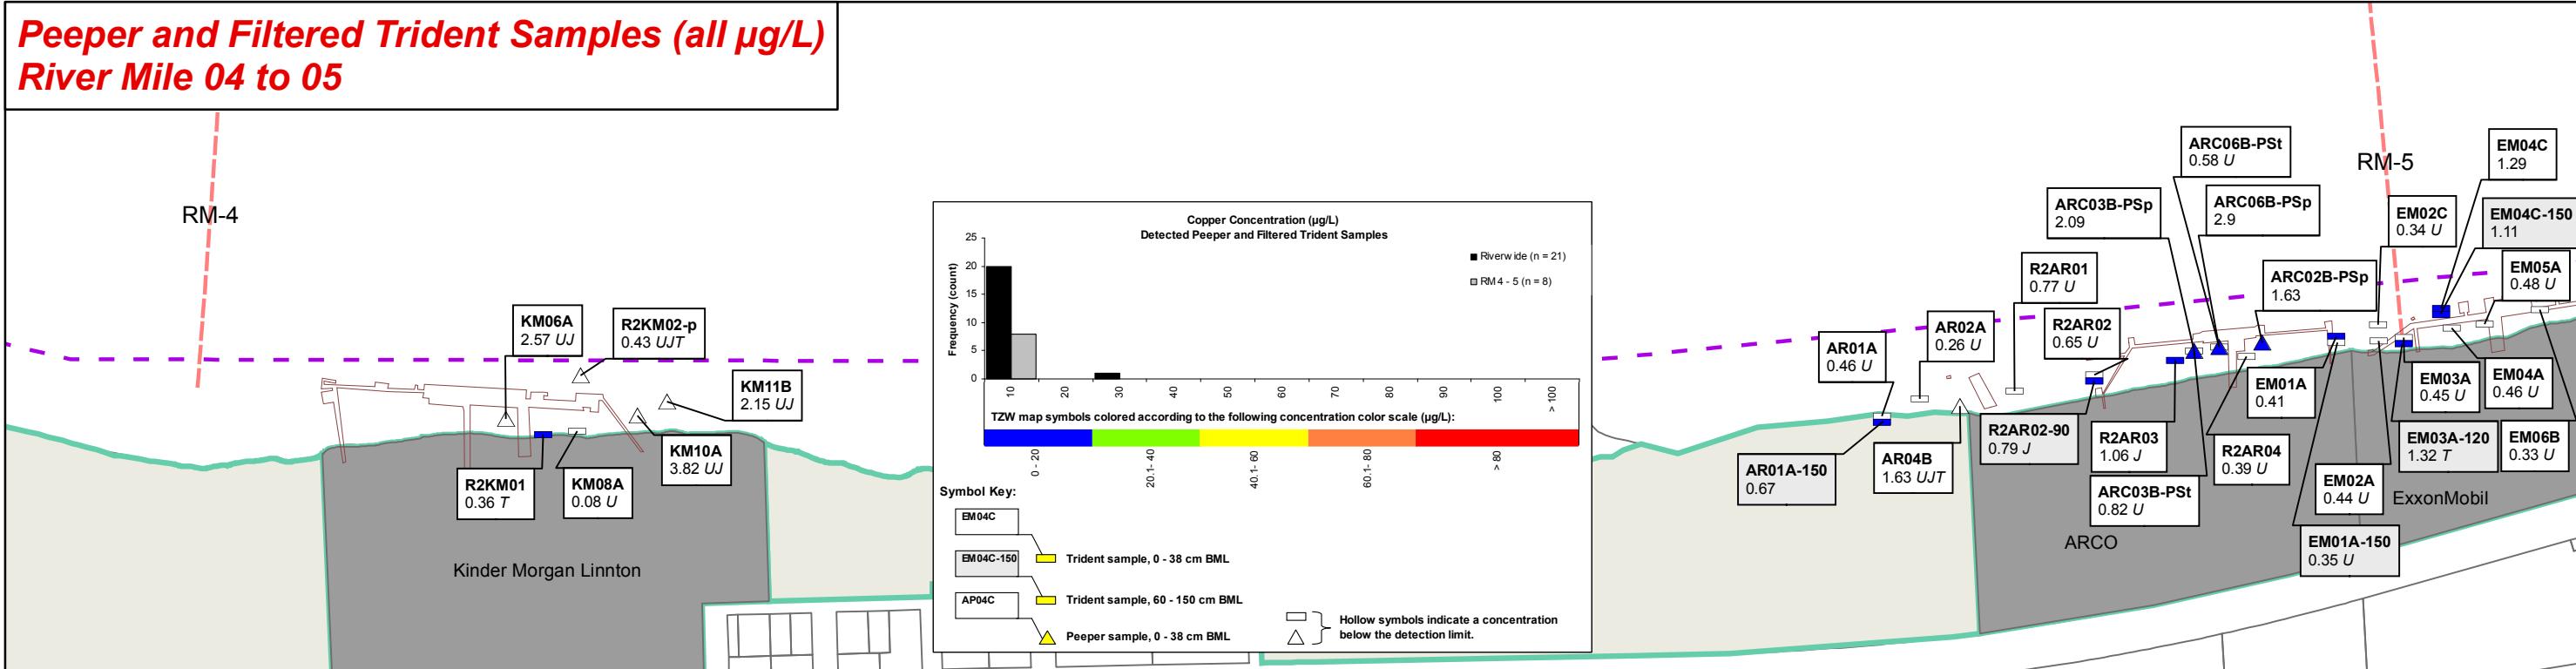
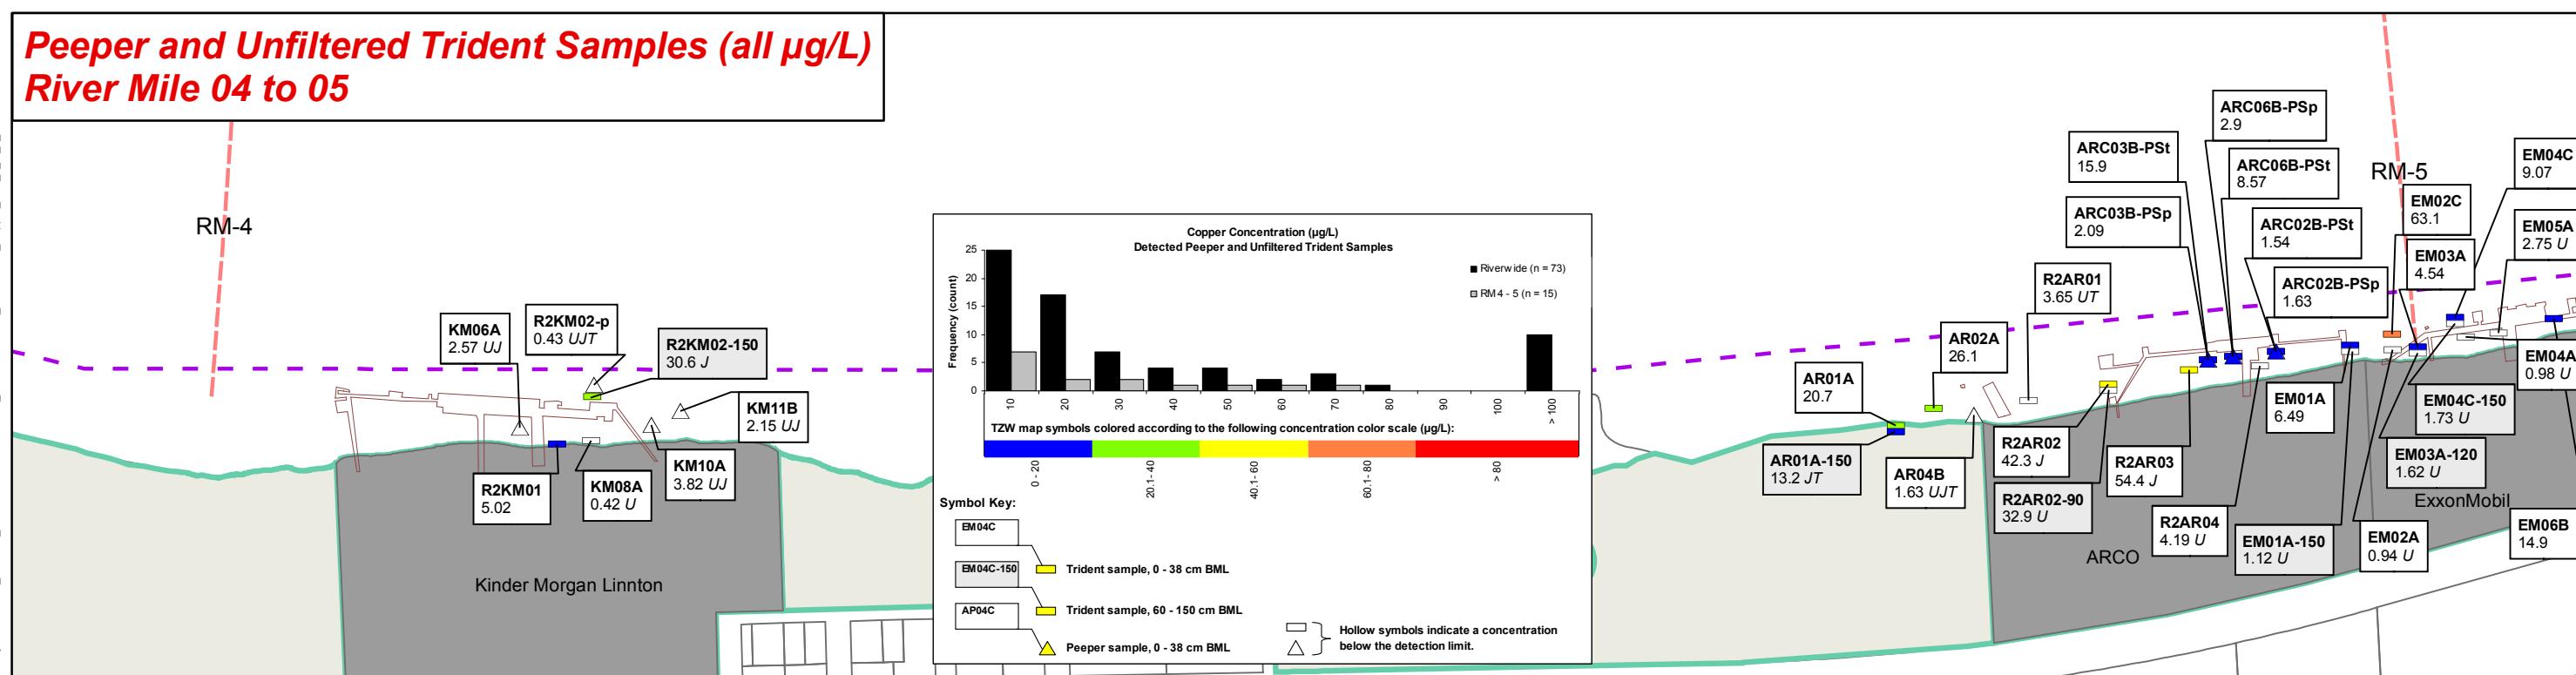
Map 5.5-5a

**Peeker and Filtered Trident Samples (all $\mu\text{g/L}$)
River Mile 04 to 05**

**Peeker and Unfiltered Trident Samples (all $\mu\text{g/L}$)
River Mile 04 to 05**

Portland Harbor RI/FS
Remedial Investigation Report
Transition Zone Water Chemistry
Copper ($\mu\text{g/L}$)
River Mile 04 to 05

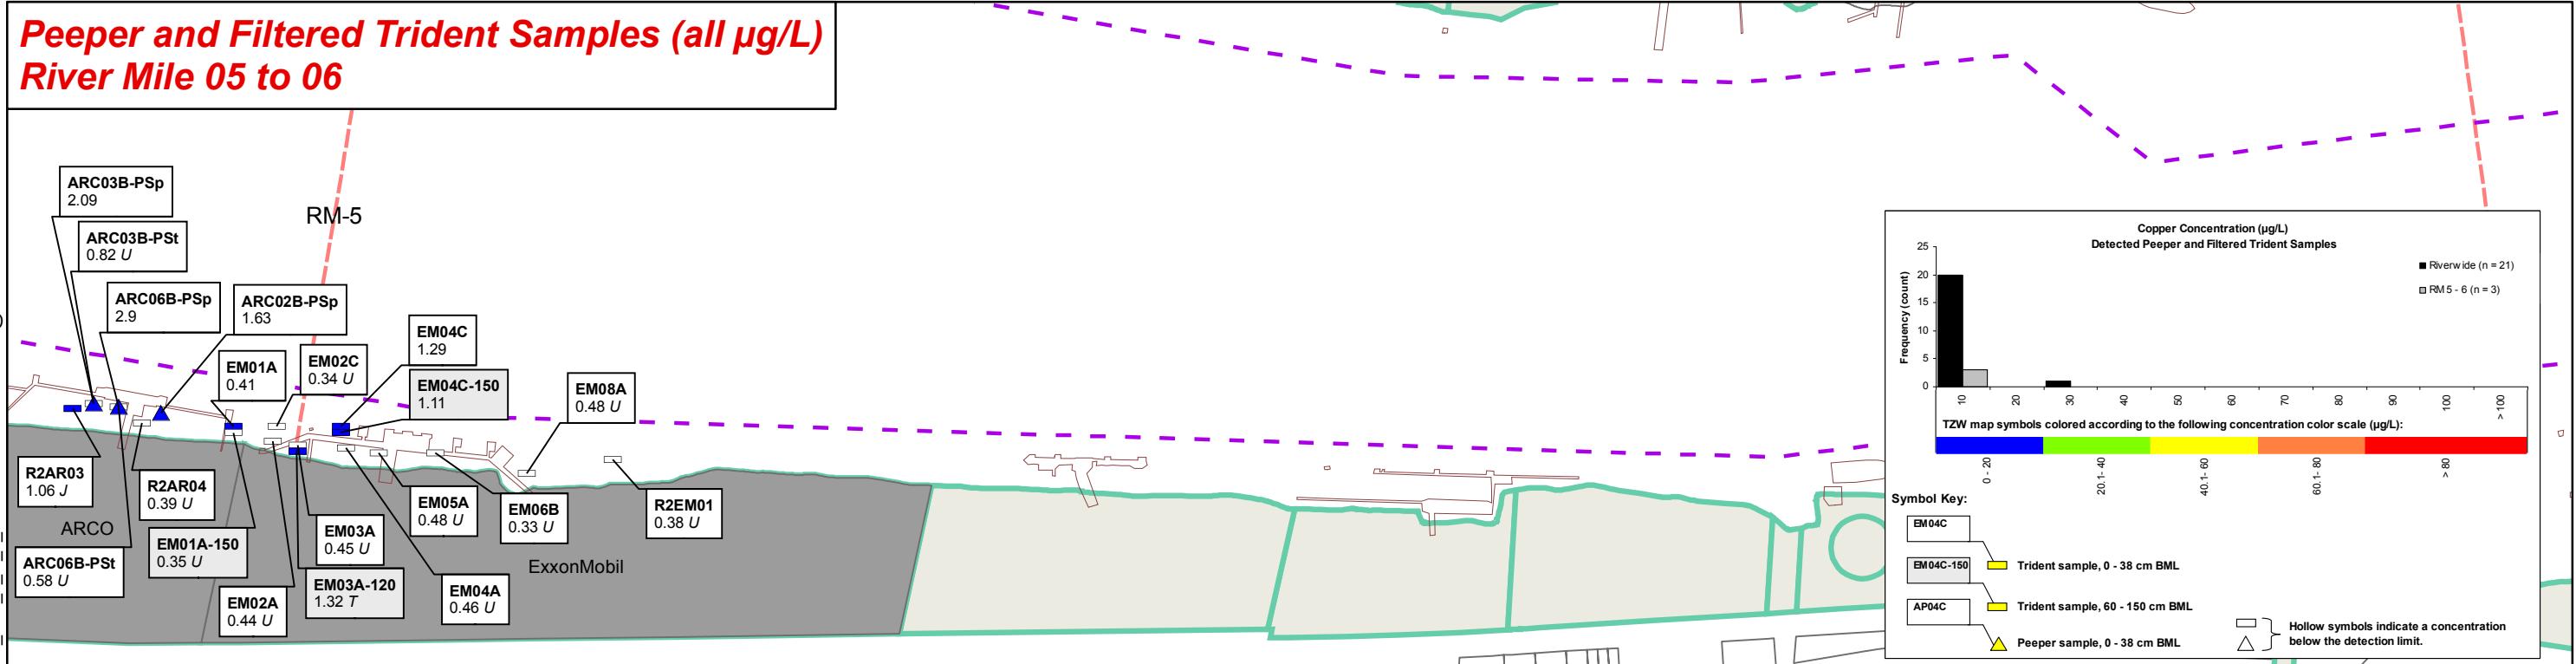
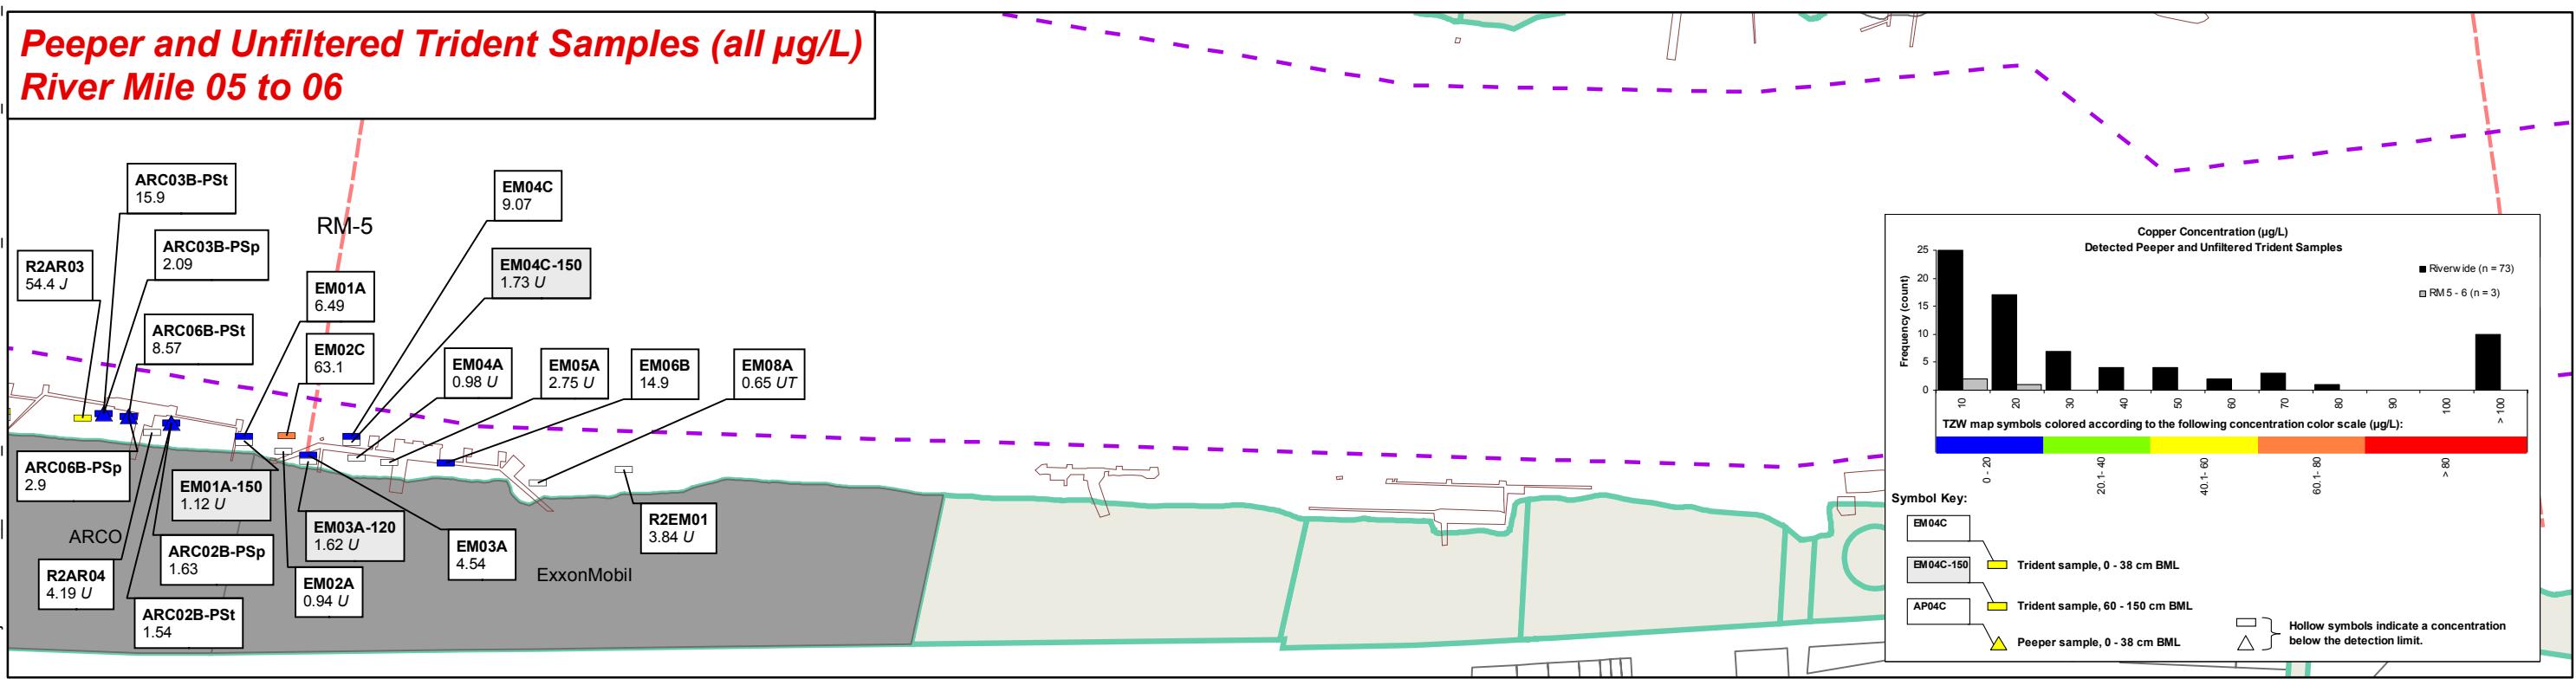
Map 5.5-5b

Portland Harbor RI/FS
Remedial Investigation Report
Transition Zone Water Chemistry
Copper ($\mu\text{g/L}$)
River Mile 05 to 06

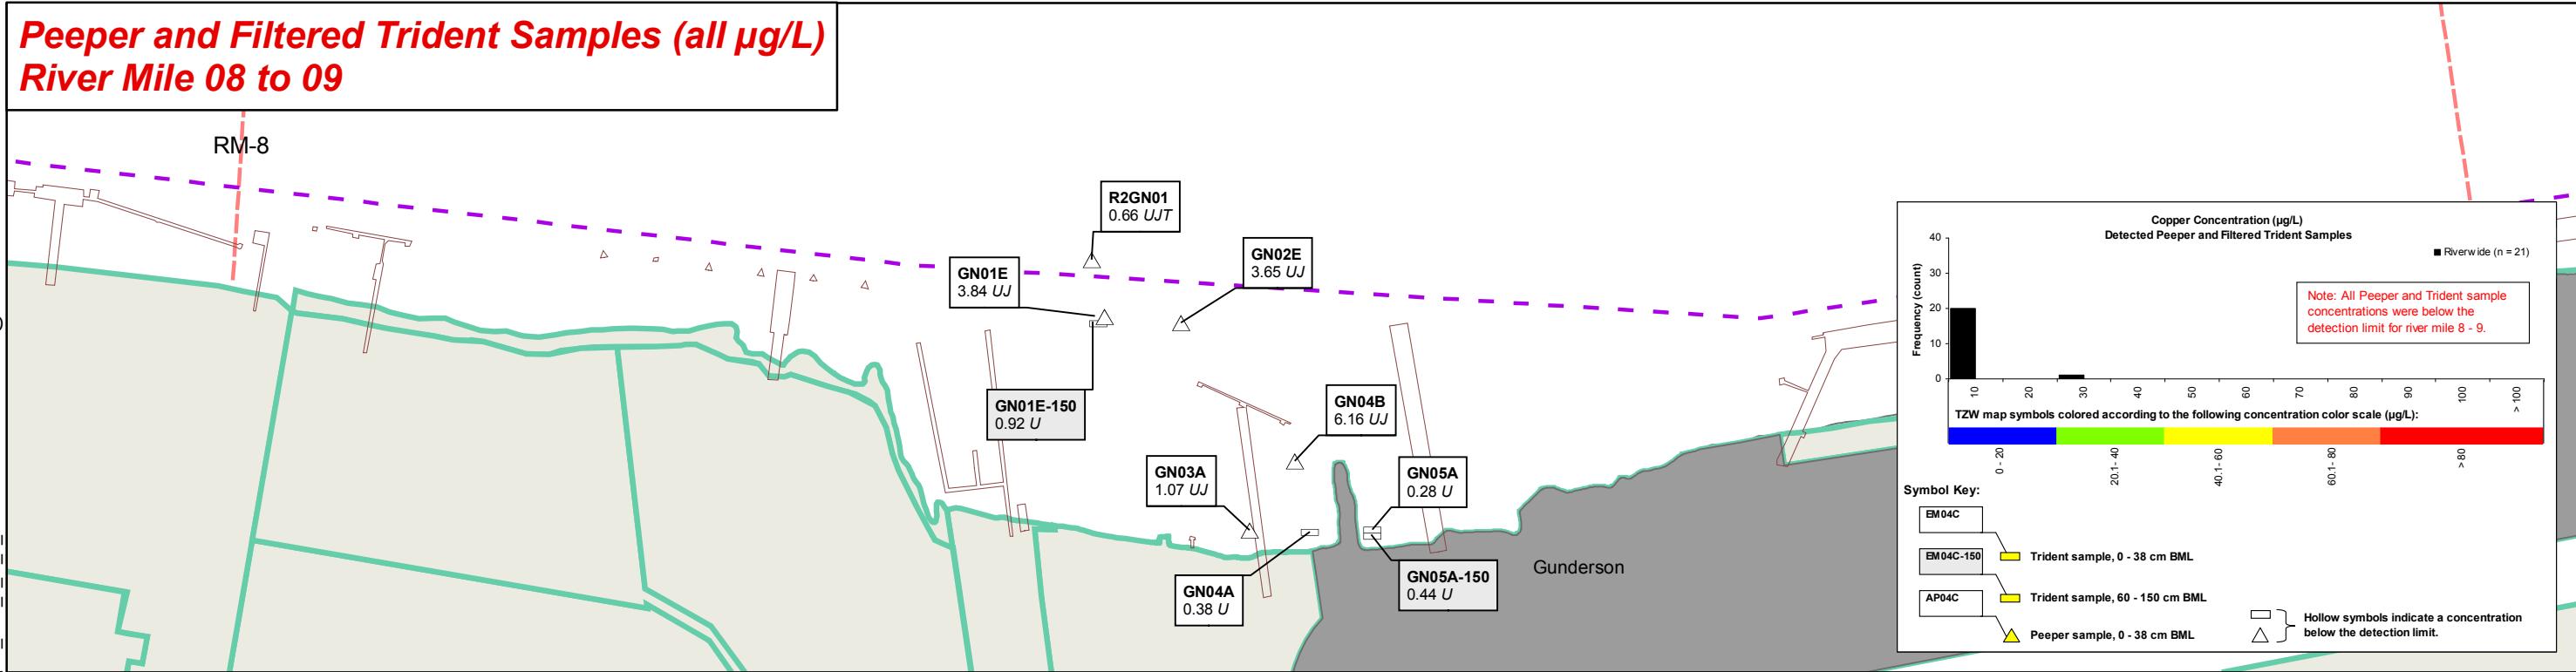
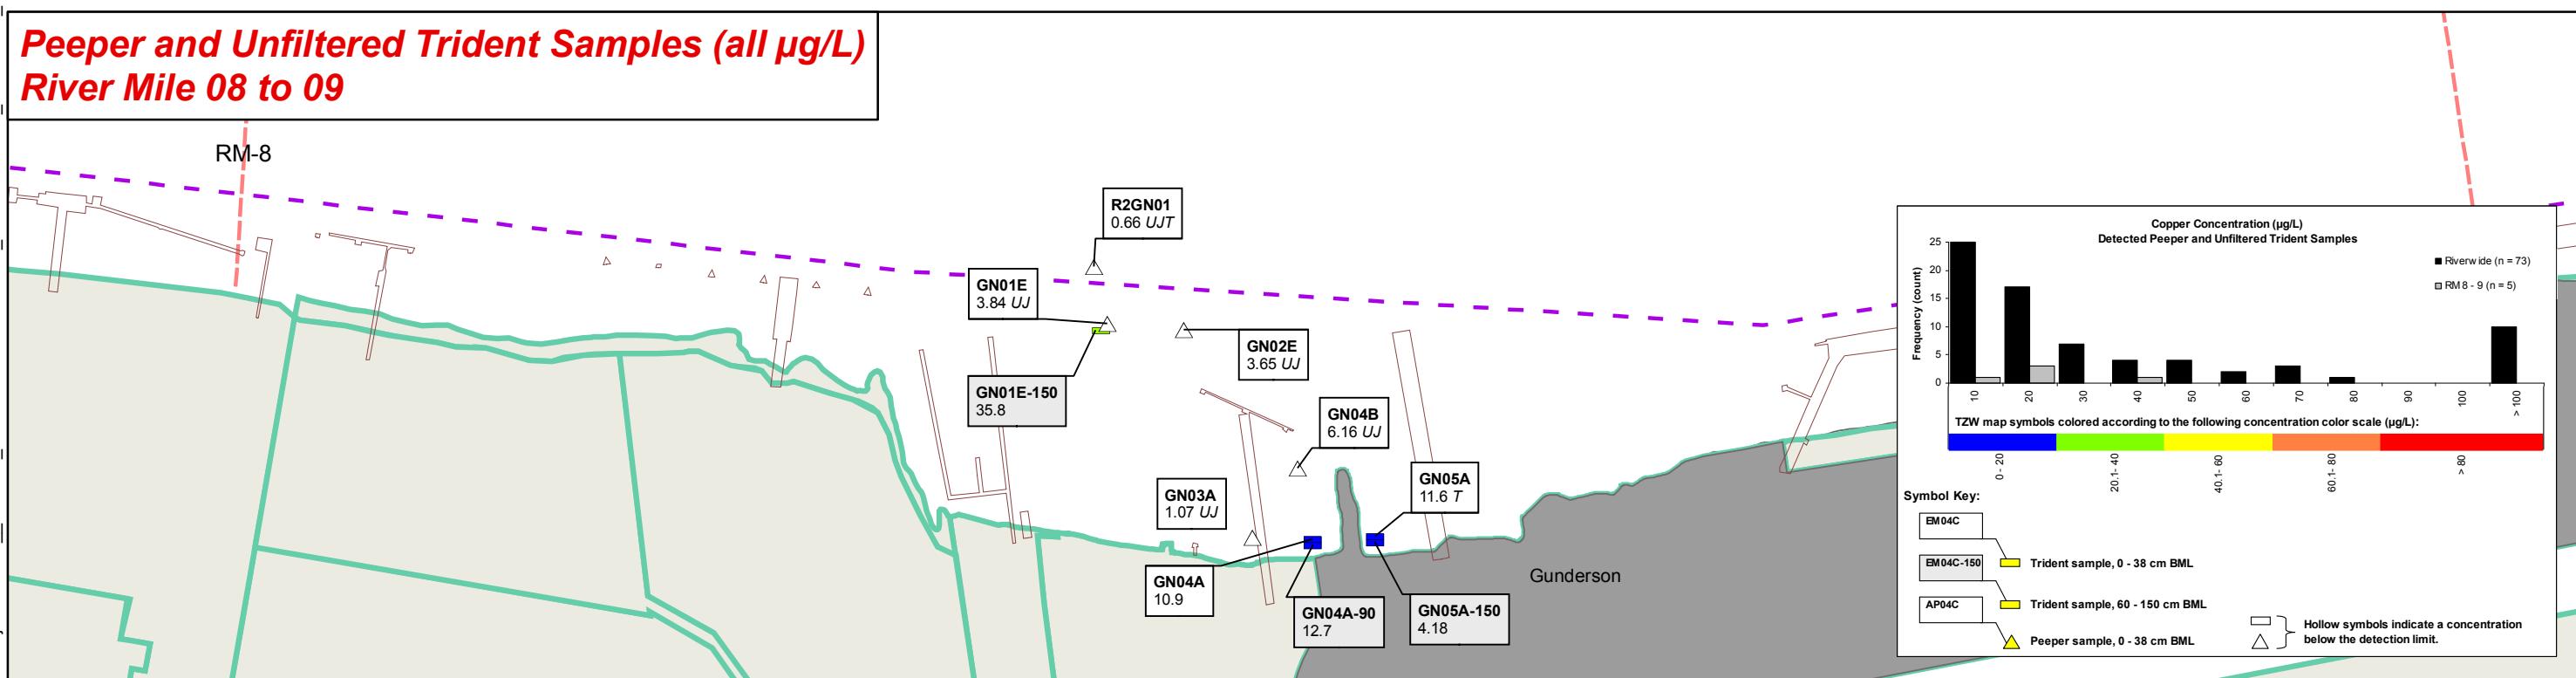
Map 5.5-5e

Portland Harbor RI/FS
 Remedial Investigation Report
 Transition Zone Water Chemistry
 Copper (µg/L)
 River Mile 08 to 09

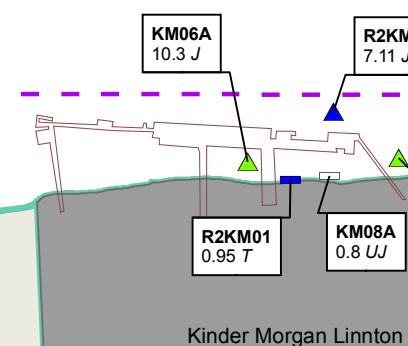
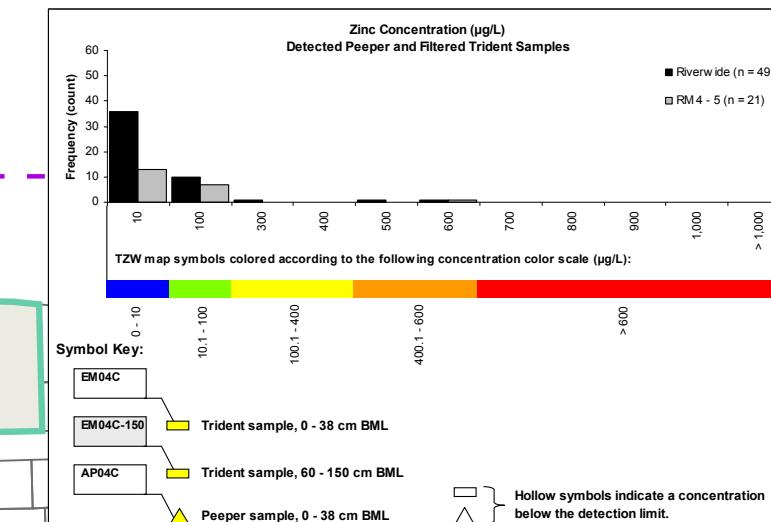
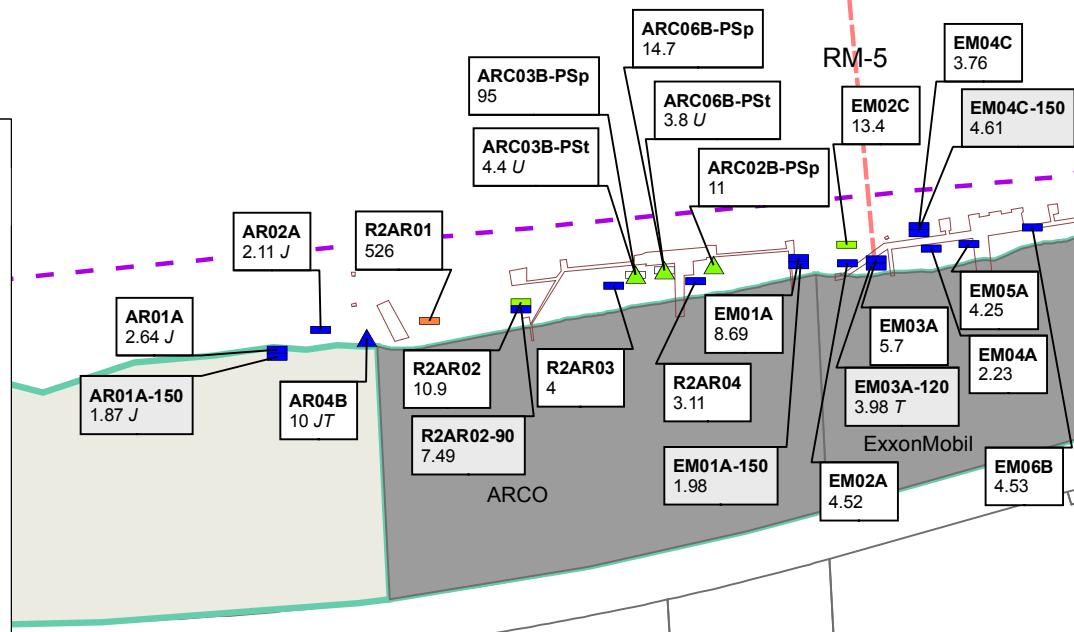
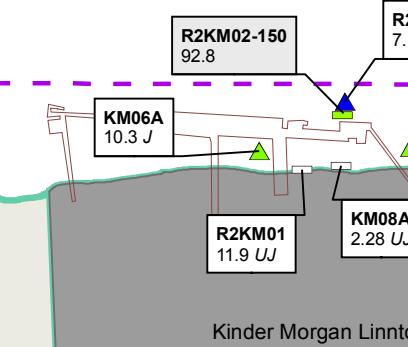
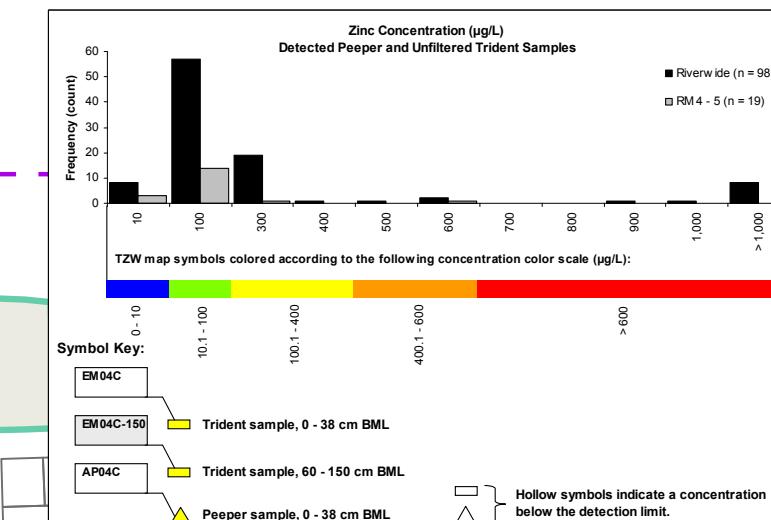
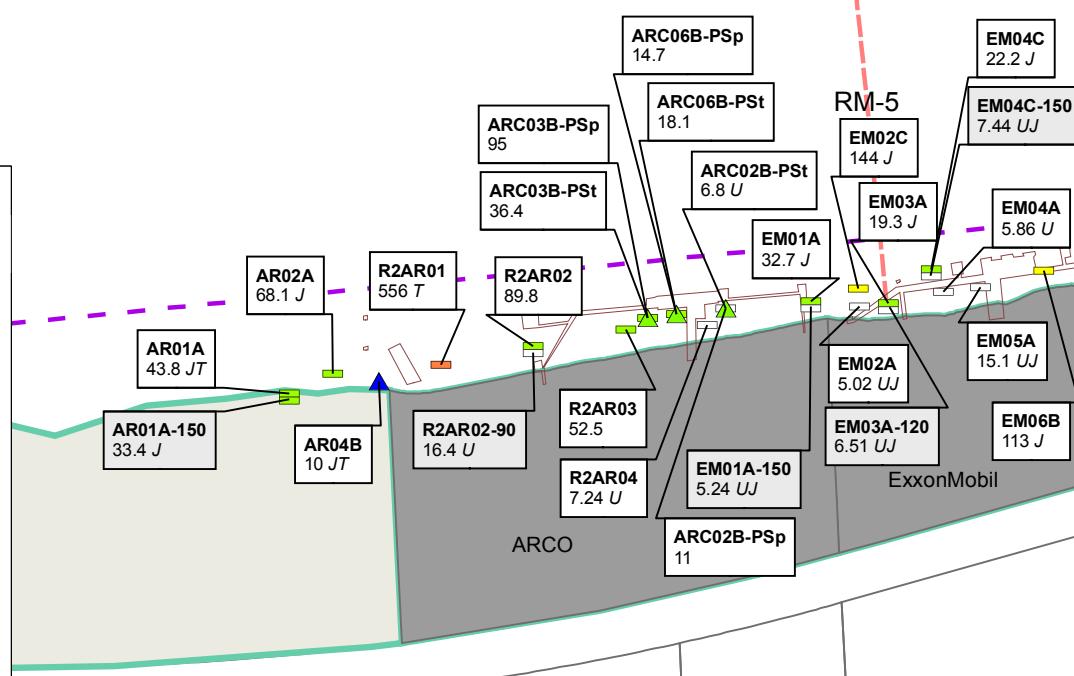
Map 5.5-6a

Peeker and Filtered Trident Samples (all µg/L)
River Mile 04 to 05

Peeker and Unfiltered Trident Samples (all µg/L)
River Mile 04 to 05

Portland Harbor RI/FS
Remedial Investigation Report
Transition Zone Water Chemistry
Zinc (µg/L)
River Mile 04 to 05

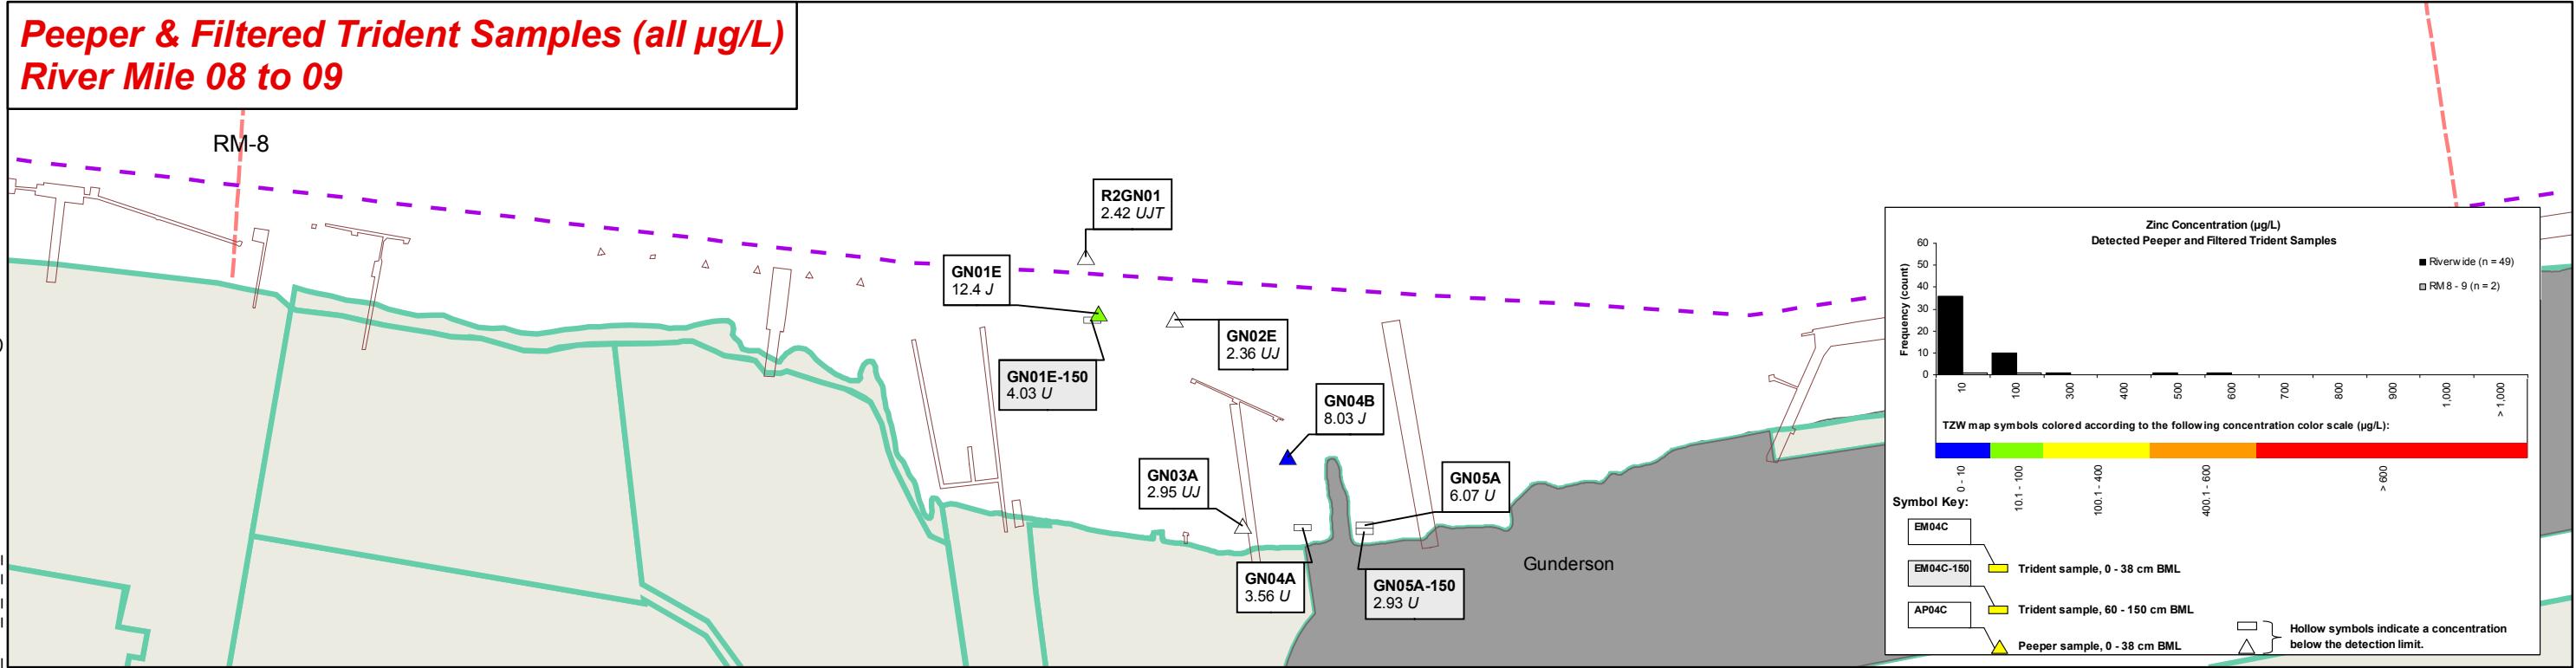
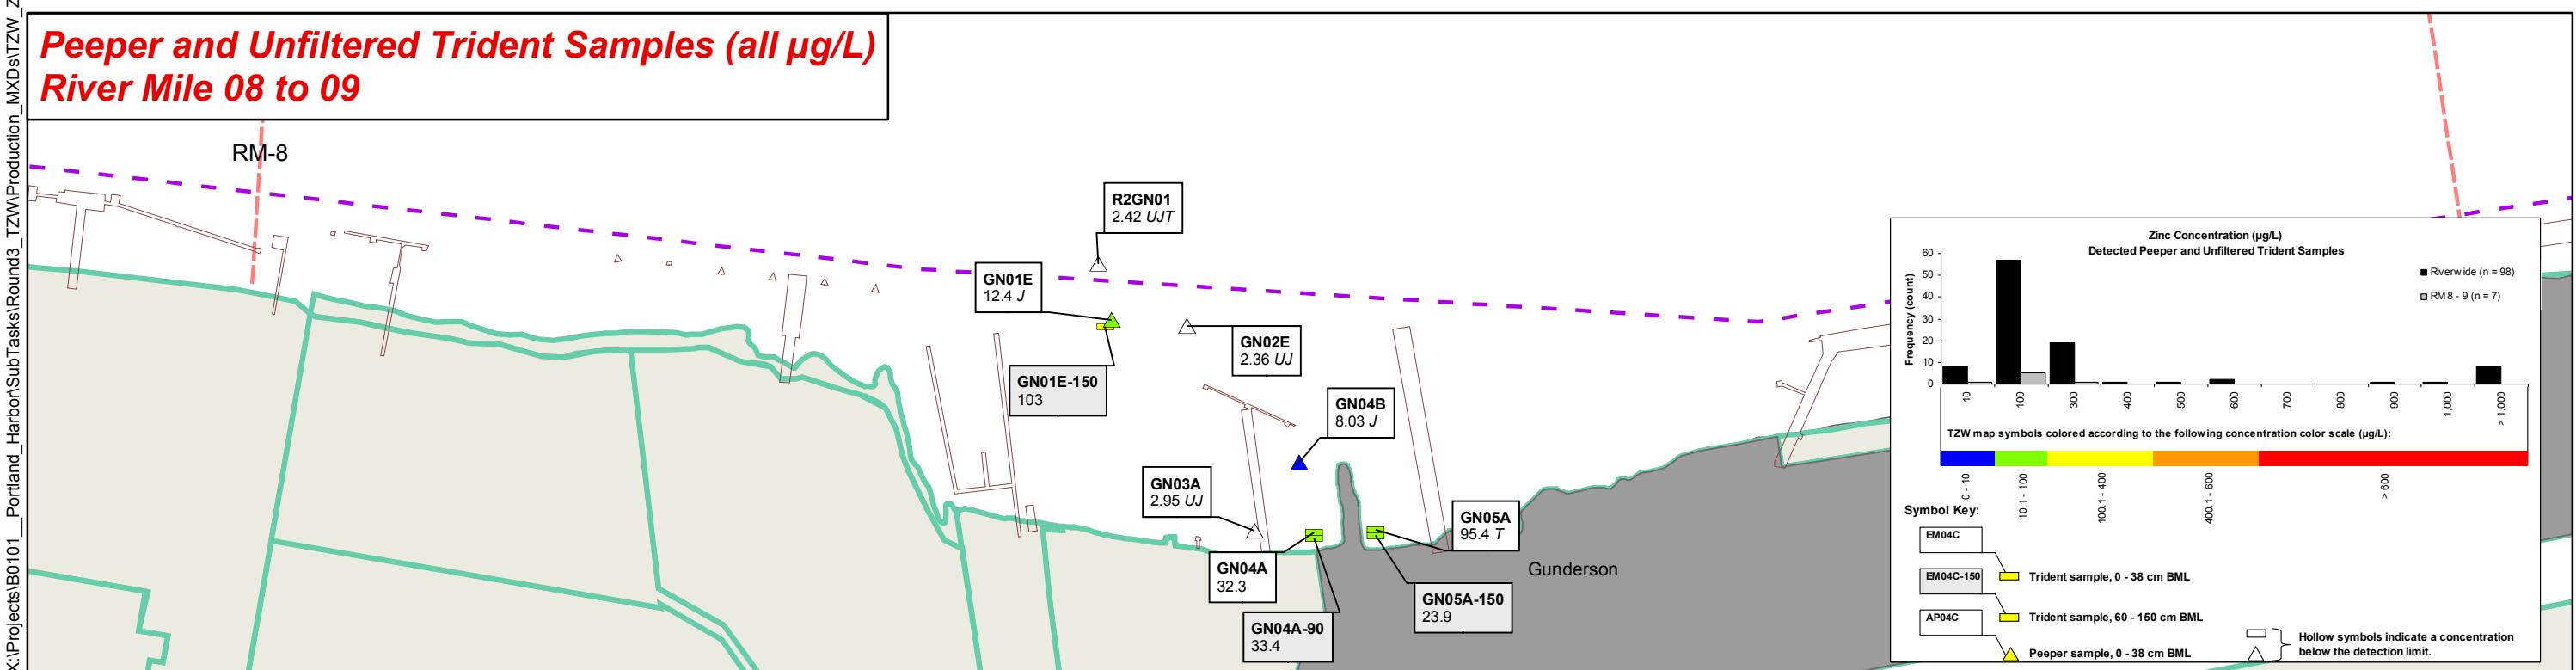
Map 5.5-6e

Portland Harbor RI/FS
Remedial Investigation Report
Transition Zone Water Chemistry
Zinc ($\mu\text{g/L}$)
River Mile 08 to 09
